**Loss of Pitch Control on Takeoff
Emery Worldwide Airlines, Flight 17
McDonnell Douglas DC-8-71F, N8079U
Rancho Cordova, California
February 16, 2000**

NTSB/AAR-03/02

**National
Transportation
Safety Board**
Washington, D.C.

The National Transportation Safety Board determined that the probable cause of the accident was a loss of pitch control resulting from the disconnection of the right elevator control tab. The disconnection was caused by the failure to properly secure and inspect the attachment bolt.

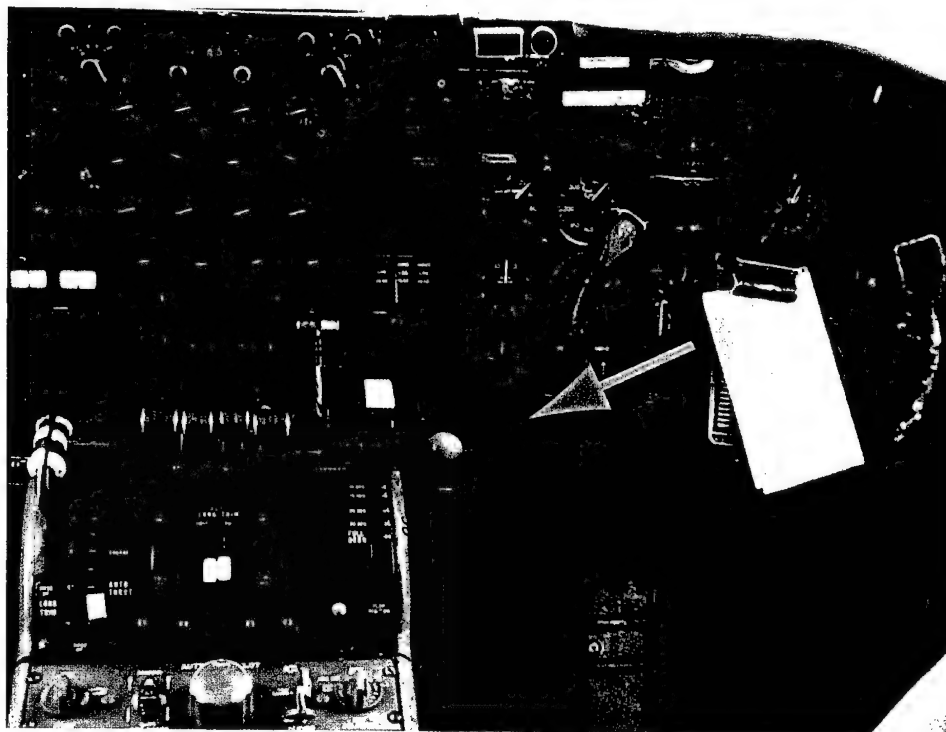
The EPI on the accident airplane was located on the lower left side of the first officer's instrument panel. (Figure 4 shows an EPI installation similar to that on the accident airplane.) The EPI gauge was installed in 1979 by the then-operator of the accident airplane, United Airlines, in compliance with Airworthiness Directive (AD) 78-01-15, which required DC-8 operators to install an EPI system in accordance with Douglas Service Bulletin (SB) 27-254, dated March 5, 1975. The FAA issued AD 78-01-15 as a result of a series of accidents and incidents involving DC-8 jammed or restricted elevator surfaces that began in 1970. (For additional information regarding these instances of jammed/restricted DC-8 elevators, see section 1.6.2.2)

AD 78-01-15 specified that operators install the EPI gauge on the first officer's instrument panel such that full forward movement of the control column and wheel would not obstruct the first officer's view of the gauge. The AD did not comment regarding visibility of the gauge from the captain's seat. As a result, DC-8 operators installed the EPI where they found room for it and where the first officer could see it on an airplane's existing instrument panel. Because Emery purchased its DC-8s from several other operators and EPI placement was not standardized, EPI gauges in Emery's fleet were installed in several different locations; according to Emery personnel, however, they were generally installed on the lower portion of the first officer's instrument panel.

Figure 4. EPI installation on the lower left side of the first officer's instrument panel (shown by the yellow arrow), similar to that on the accident airplane.

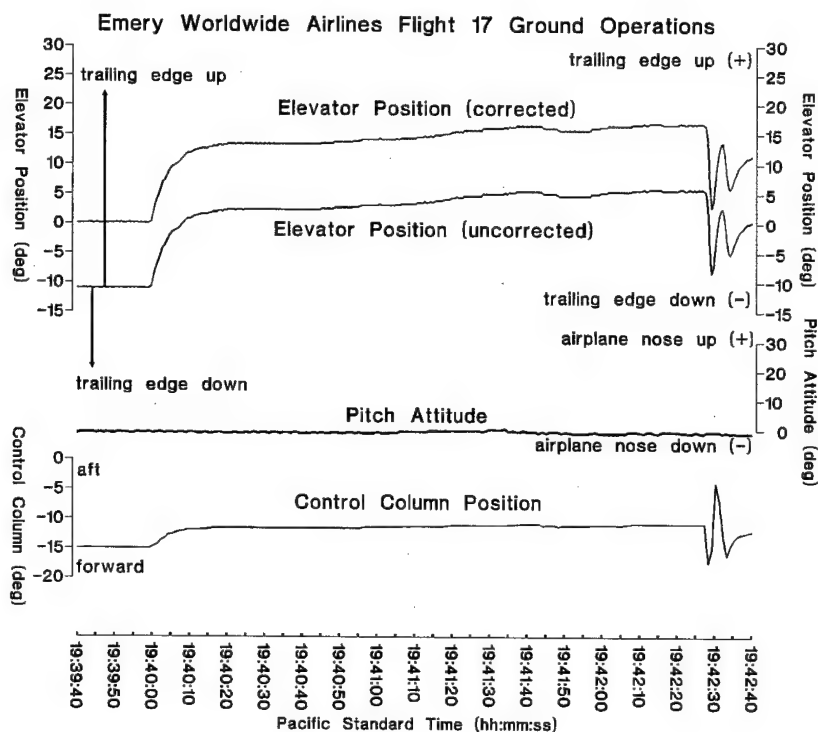
Figure 6 shows the elevator, pitch, and control column plots recorded by the accident airplane's FDR during ground operations before the accident flight. On this plot, the uncorrected data on the far left side of the plot shows an 11° TED elevator deflection when the gust lock was engaged (and the elevator was in its neutral, or 0°, position).

Figure 6. Elevator, pitch, and control column plots recorded by the accident airplane's FDR during ground operations before the accident flight. The first 20 seconds of data were recorded while the gust lock was engaged.

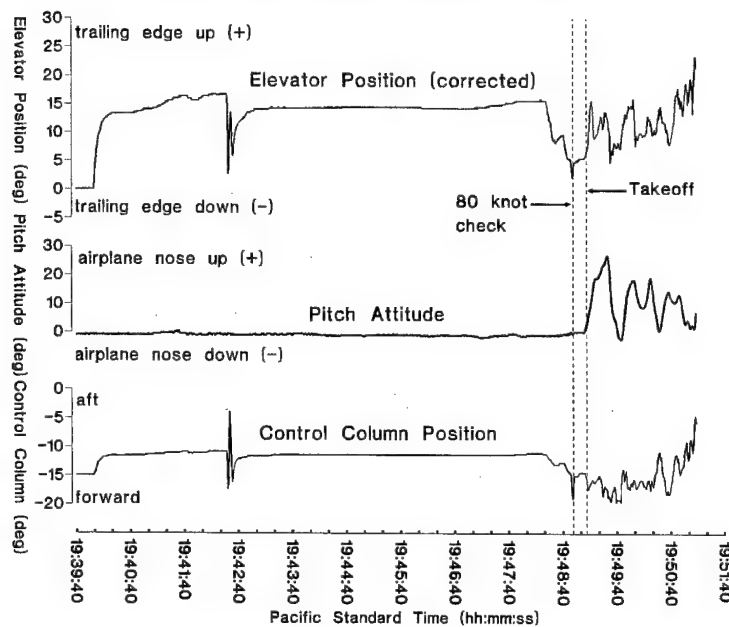
The Safety Board's examination of the corrected elevator position data revealed that the airplane's elevator never traveled below its neutral position to a TED deflection during the accident flight, although recorded forward control column inputs should have resulted in a TED elevator deflection. For example, although the FDR data indicated that, during the 80-knot elevator check at MHR, the control columns were moved to about 6° forward of their rigged neutral position, the elevators did not deflect below 2.2° TEU. In contrast, during the 80-knot elevator check on the previous takeoff (at RNO) the FDR recorded elevator movement to 8° TED, with less forward control column movement. Figure 7 shows plots of the pitch attitude, control column position, and elevator position FDR data for the accident flight. Elevator position is shown using the conversion that corrected for the 11° offset. Figure 7 also shows when the 80-knot elevator check and takeoff occurred. Figure 8 shows the same information for the takeoff from RNO.

Figure 7. Pitch attitude, control column position, and (corrected) elevator position FDR data from the accident flight. About the first 20 seconds of data were recorded while the gust lock was engaged.

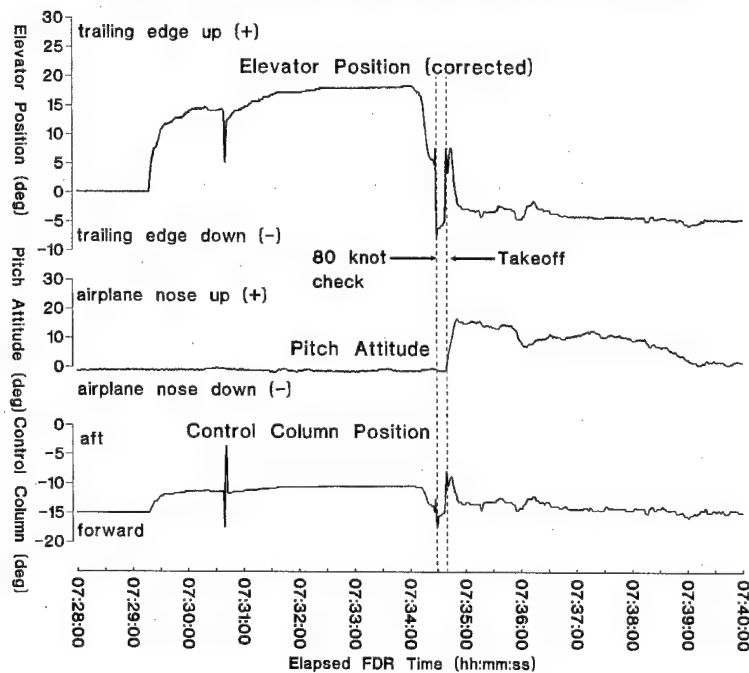
Figure 8. Pitch attitude, control column position, and (corrected) elevator position FDR data for the previous takeoff from RNO. About the first 1 minute 20 seconds of data were recorded while the gust lock was engaged.

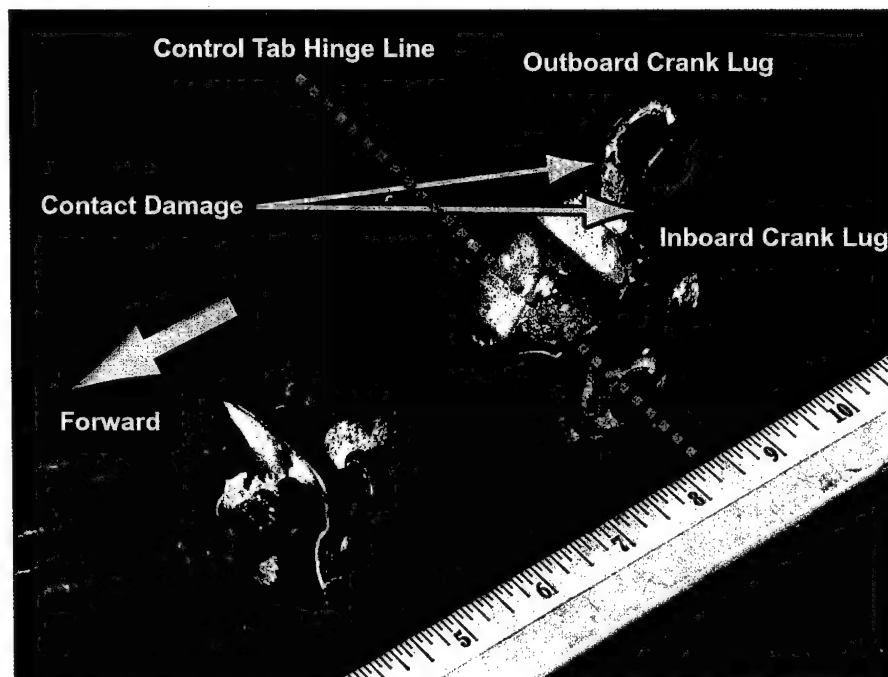
(See figure 2, in section 1.6.2, for a diagram of the elevator control tab installation.) The right control tab pushrod was recovered separately, with its aft rod end (which would normally have been bolted to the tab crank fitting) intact. Examination of the forward edges of the elevator control tab crank fitting lugs revealed evidence of repeated contact damage (including gouge marks and indentations). (Figure 9 is a photograph of damage to this area.) The internal surfaces of the pushrod aft rod end bearing and the bushings in the crank fitting lugs showed no visible signs of damage or deformation. The bolt and associated hardware that normally secures the right elevator control tab pushrod to the tab crank fitting⁶¹ was missing and not recovered.

Although the inboard portions of the left elevator, control tab, crank fitting, and attachment hardware were not recovered and were presumed consumed by postcrash fire, the left elevator control tab pushrod was recovered. Unlike the right control tab pushrod, the left control tab pushrod's aft rod end (normally attached to the tab crank fitting) was fractured and about 75 percent of it and its associated bearing were missing. The forward end of this pushrod was fractured at its rod end attachment holes, and the pushrod had about an approximately 90° bend at its midpoint. No fire damage was observed on the left control tab pushrod assembly.

Figure 9. A photograph of the accident airplane's right elevator control tab crank fitting. Note damage on forward face of control tab crank fitting lugs.

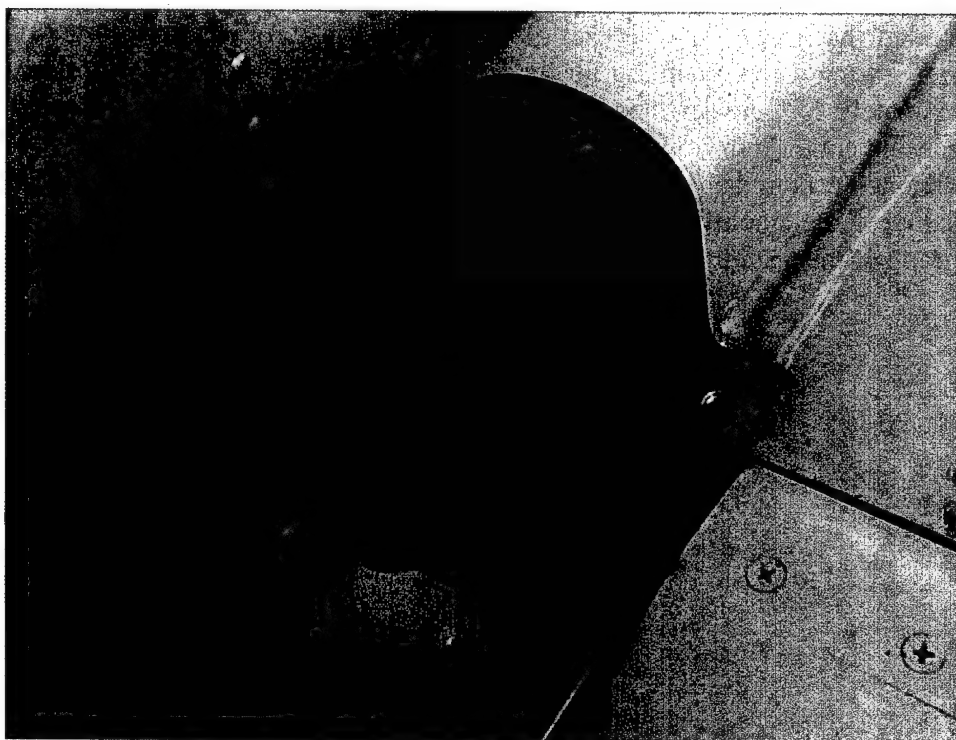
When the aft end of the test airplane's pushrod cleared the crank fitting, it shifted slightly inboard so that it was aligned with the inboard leg of the forward face of the crank fitting. When the test airplane's control tab was manually raised TEU (simulating the effects of aerodynamic forces that would be experienced during the takeoff roll), the crank fitting contacted the aft rod end, obstructing any attempt to further deflect the elevator control tab in the TEU direction. Figure 10 shows the test airplane's pushrod in this position.

Figure 10. Photograph of the test airplane's right elevator control tab pushrod contacting the crank fitting.

When the test airplane's elevator surfaces were manually moved to their TEU limit (about 27° TEU) in this condition, the control columns moved aft from 15.0° forward of vertical (the position in which they were held by the centering device) to about 8.8° forward of vertical, and both elevator geared tabs moved to 27.5° TED. The left elevator control tab deflected fully to about 8.5° TEU; however, the right elevator control tab could not be moved further in the TEU direction than 15.9° TED because of interference with the disconnected pushrod.

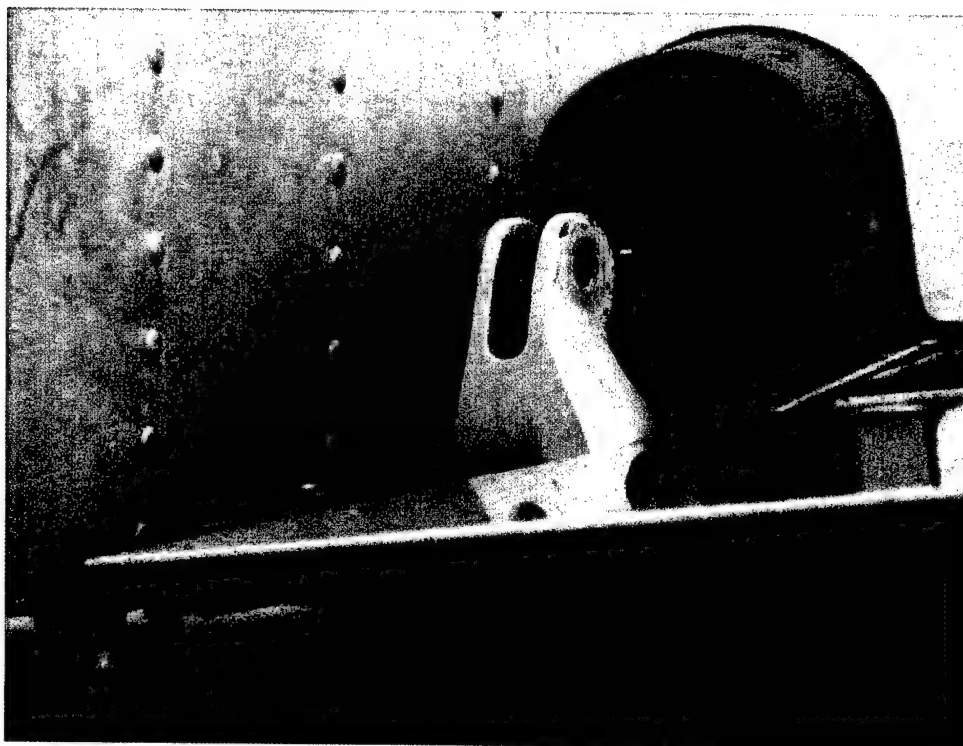
Because a free elevator control tab pushrod might not necessarily always displace itself inboard into alignment with the crank fitting as it did on the test airplane (especially if the pushrod is disconnected while the airplane is in flight and aerodynamic forces are acting on the flight control surfaces), the Safety Board examined other potential interference modes between a free elevator control tab pushrod and crank fitting. These tests revealed that in general, contact between a free pushrod and the forward face of either crank fitting lug (accounting for rod end misalignment, etc.) resulted in a mismatch of approximately 25° between the left and right control tabs. These tests also revealed that a disconnected control tab could be rotated about 3° to 4° in the TEU direction if the crank fitting remained centered about the pushrod; however, further movement was restricted by contact between the crank fitting and shoulders of the aft end of the pushrod. Figure 11 is a photograph of the test airplane's control tab in this position.

Figure 11. Photograph of the test airplane's disconnected right elevator control tab pushrod centered between the lugs of the crank fitting with the control tab rotated 3° to 4° in the TEU direction after the attachment bolt was removed.

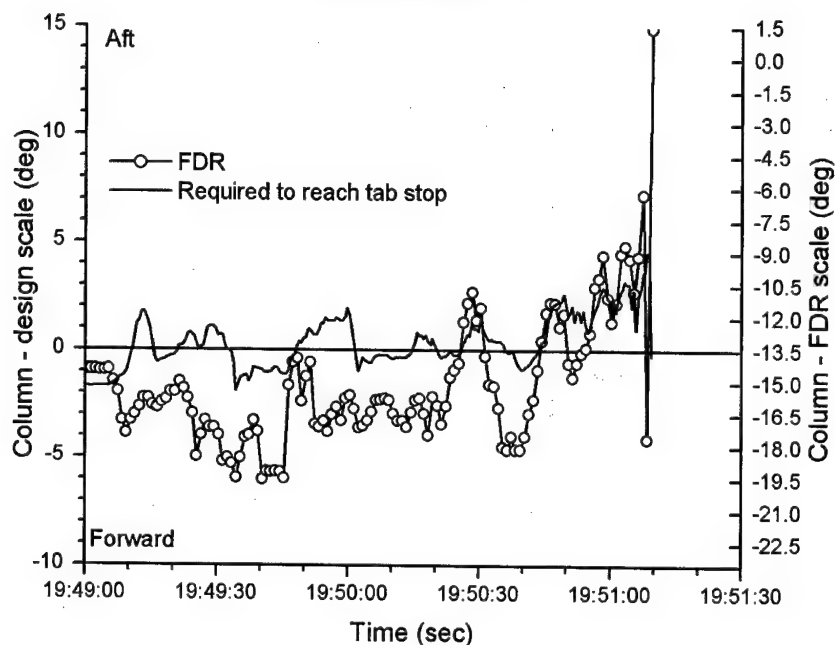
The Safety Board's examination of the FDR data for the flights preceding the accident flight revealed that a change in the relationship of control column movement to elevator response occurred about 8 minutes and 20 seconds before the accident airplane landed at MHR. The Board's performance study derived the control tab positions at the time of this change. The study showed that the change in FDR data could be explained by a shift of about 3° to 4° in the TEU direction of the right control tab, assuming that the right control tab's pushrod to crank fitting attachment bolt separated at this time. This change in the FDR data was evident until the airplane landed at MHR. As previously discussed, a scenario in which a disconnected pushrod remained between the lugs of the aft crank fitting (shown in figure 11) resulted in a 3° to 4° control tab shift in the TEU direction.

Figure 12. The control column position required for the left elevator control tab to reach its TEU physical stop (for the recorded elevator position) and the actual recorded control column position for the accident flight.

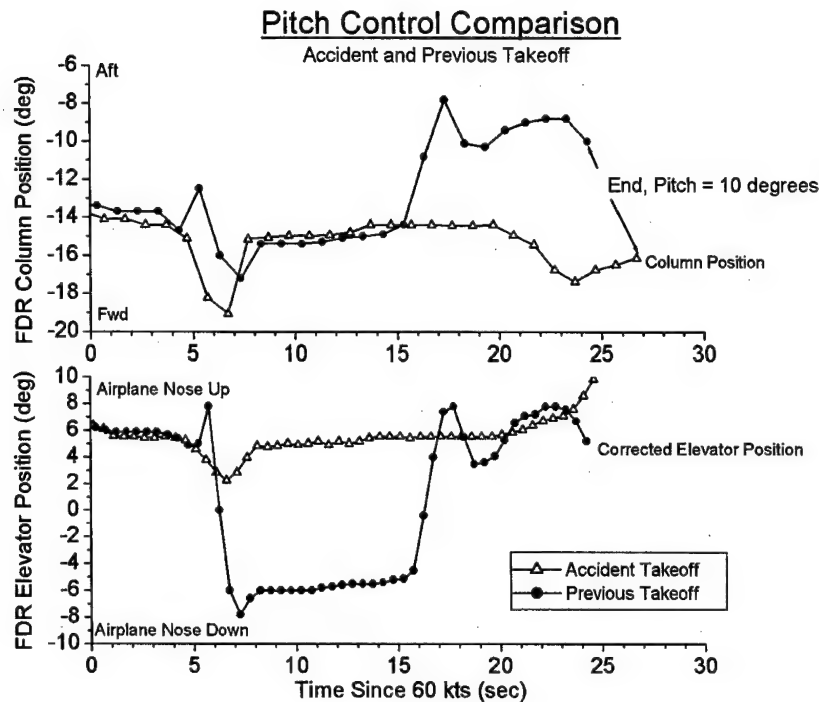
The study also showed that the stabilizer moved in an ANU direction at the same time that the pilot pushed the control column forward to resume the descent after a brief period of level flight at 10,000 feet. The direction of this stabilizer movement was opposite that which would be expected when the pilot provided a forward control column input. The study showed that the slight ANU stabilizer shift balanced the effect of the change in the relationship between the recorded elevator and control column movements and that the elevator remained responsive to pilot input. Figure 13 shows plots of the control column and elevator for the accident takeoff roll and the previous takeoff roll (from RNO).

Figure 13. Plots of the control column and corrected elevator position recorded by the accident FDR during the accident takeoff roll and the previous takeoff roll (from RNO).
